Case study--when the device can't be connected to any supported car models

OBD test cable testing method:

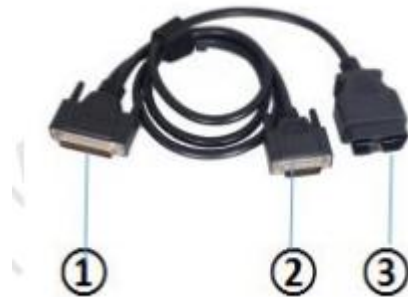
Pay attention that there are 3 connectors on the OBD cable:

Connector 1: connect K518ISE OBD port;

Connector 2: connect KPROG adaptor

Connector 3: connect the vehicle OBD port

Pic 1: 3 connectors on OBD cable

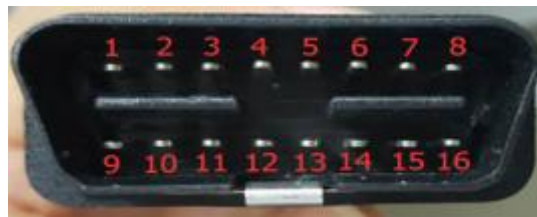
Step 4: Use the black pen to test the resistance of each pin of the vehicle connector (As shown in pic 3) , make sure that you hold the vehicle connector in the way just as the pic shows:

Pic 3: 16 pins on the vehicle OBD connector

PIN 1 and 8 should have no resistance; PIN2,3,4,5,6,7,9,10,11,12,13,14,15,16 should have resistance.

If all have no resistance, then it will be DB25 cable has problem; if the measurement is all as it supposed to be, and the car models(those K518ISE supported models) still can't be connected, then you will need to sent back the DB25 cable and the main unit for Lonsdor to check(**if so, let us know, and we shall talk together about the solution and details**)
